2-207 INSPECTION OF AIRCRAFT
STRUCTURES USING MOBILE SOURCES;
A COMPENDIUM OF RADIOGRAPHIC
RESULTS

Training & Servicing/Armament Division
Naval Support Equipment Department
Naval Air Engineering Center
Lakewood, New Jersey 08730

16 APRIL 1979

Final Report for Period 15 May 1977 - 31 December 1978
NAVEDP 2000000-790000-41001-000

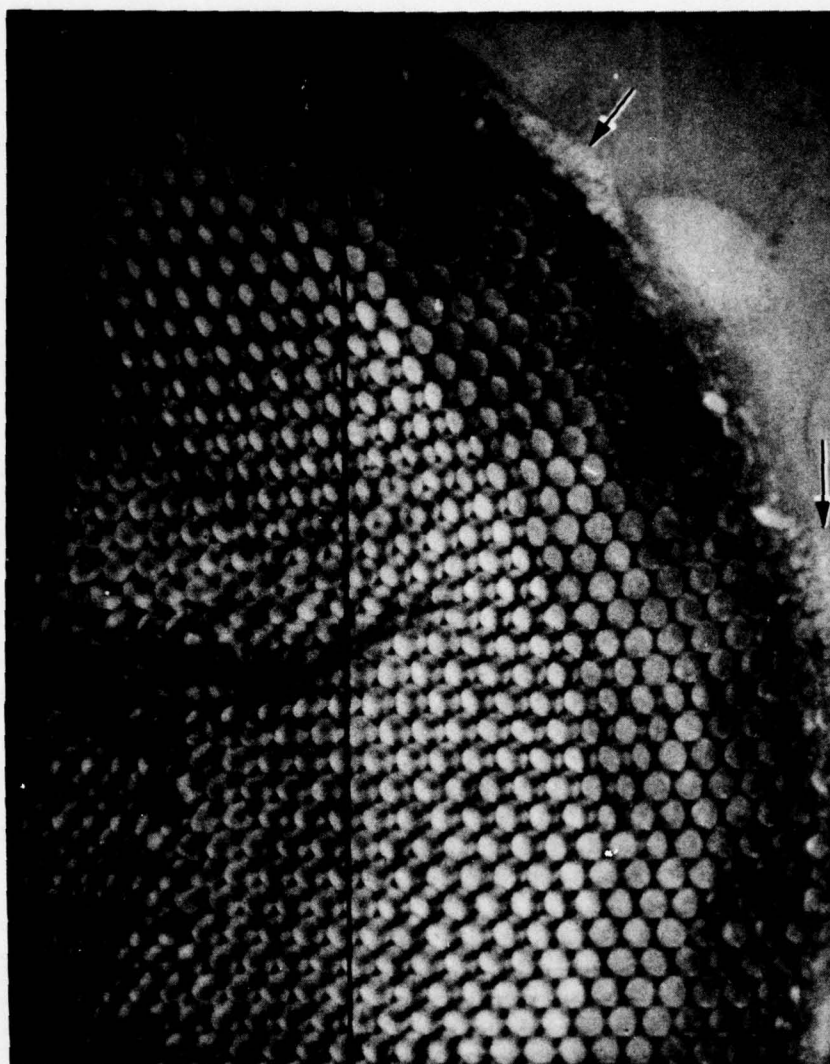
Figure 1 - Neutron Radiograph of Aluminum Honeycomb Aircraft Panel - Side 1

The area of chief interest in this radiograph is that showing the condition of the bond line in the honeycomb closeout region. Many adhesive voids are present in this area (indicated by the arrows). The aluminum core was resin-coated in this case.

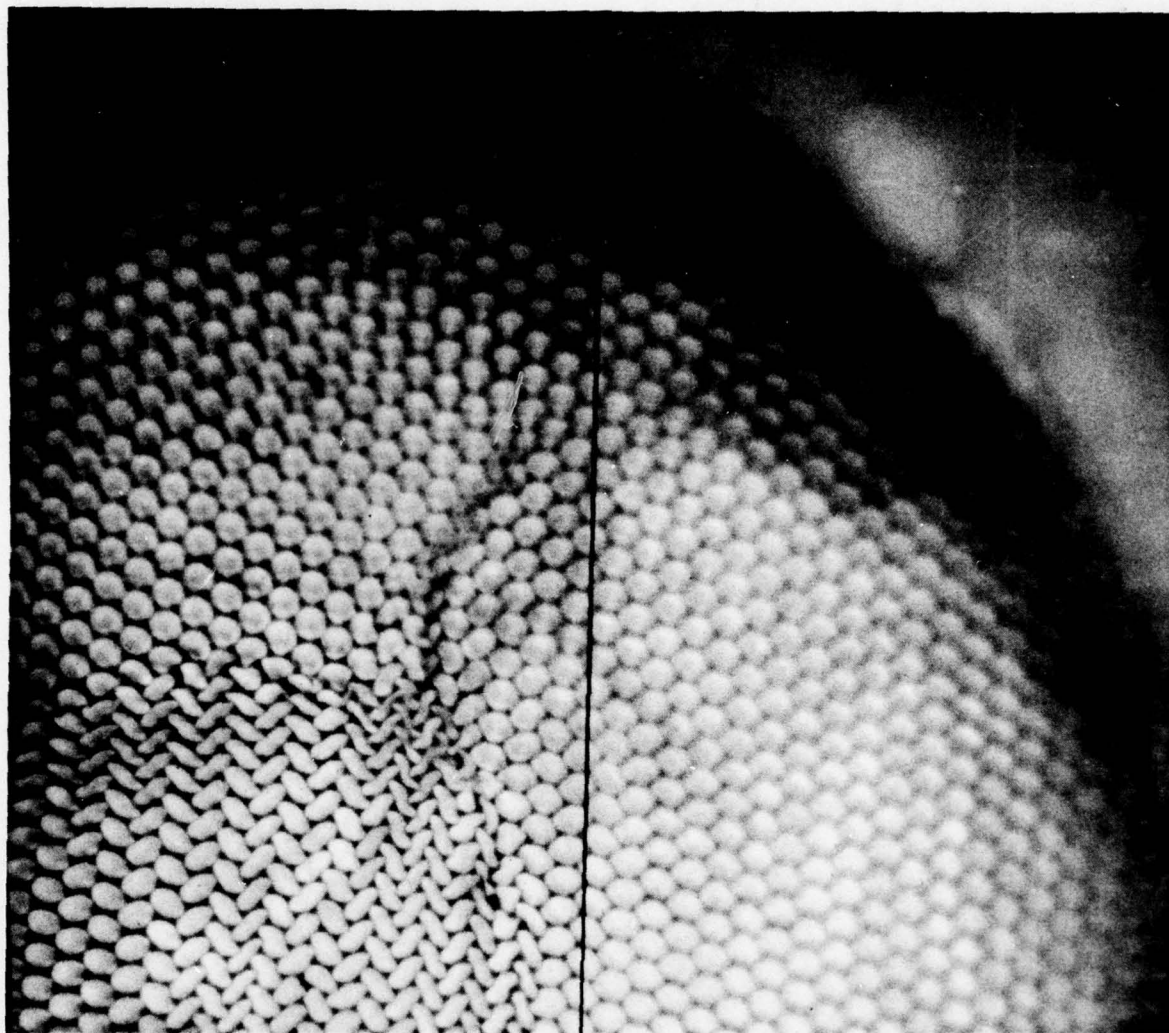
Figure 2 - Neutron Radiograph of Aluminum Honeycomb Aircraft Panel - Side 2

The skin-to-core interface on the opposite side of the panel of Figure 1 is shown here. This side, which was not "in focus" in Figure 1 now appears as a sharp image, illustrating the selectivity of imaging resulting from this type of radiographic system.

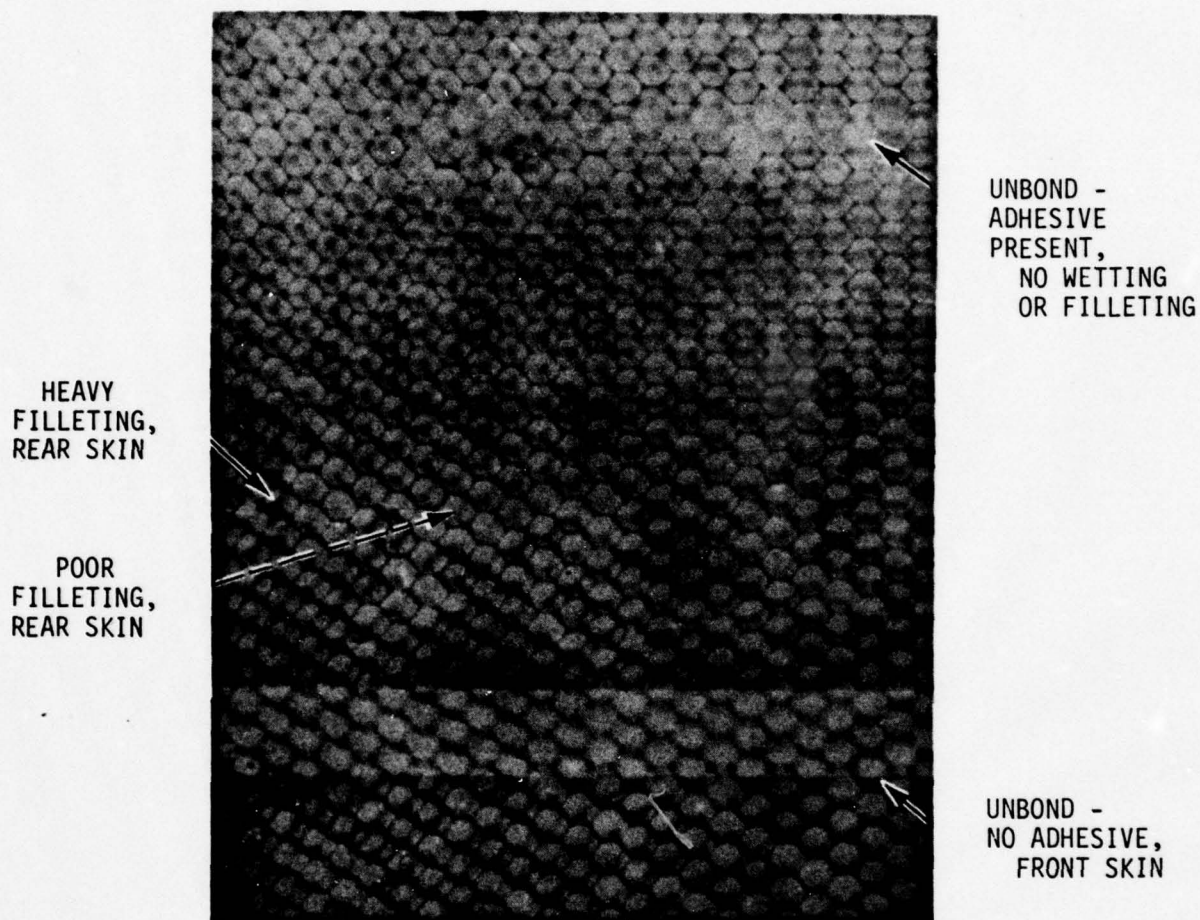
Figure 4 - Neutron Radiograph of Aluminum Honeycomb NDI Test Panel No. 1

In this NDI test panel, built-in voids and unbonds are radiographically imaged in the areas indicated:

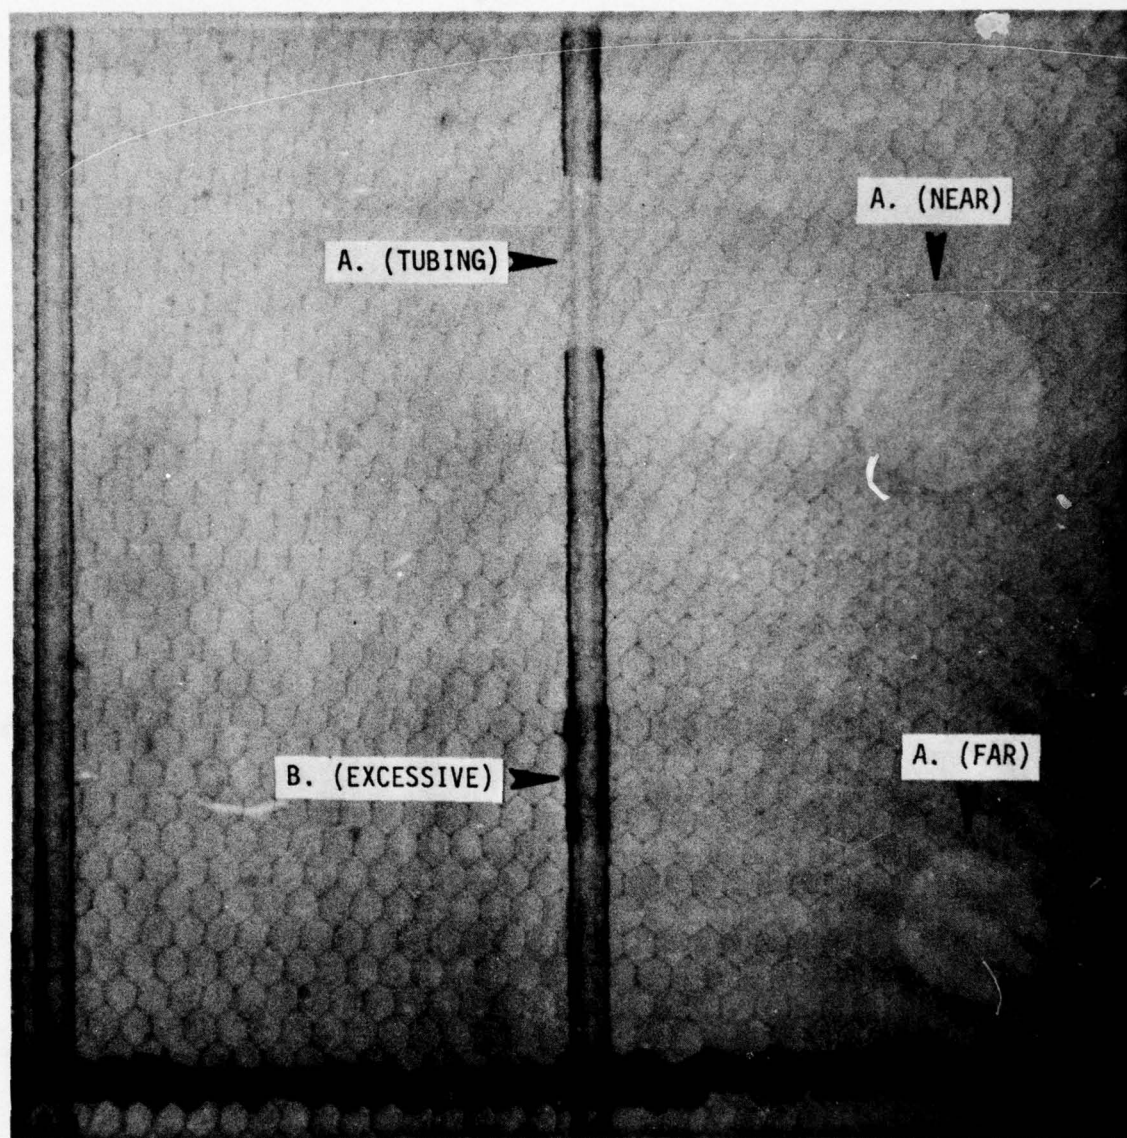
Figure 5 - Neutron Radiograph of Aluminum Honeycomb NDI Test Panel No. 2

Prepared bond-line flaws in this NDI test panel are imaged in the areas noted:

a. Adhesive deficiency in near skin-to-core bond line, in far skin-to-core bond line, and in tube bonding.

b. Excessive adhesive in tube-to-core bond.

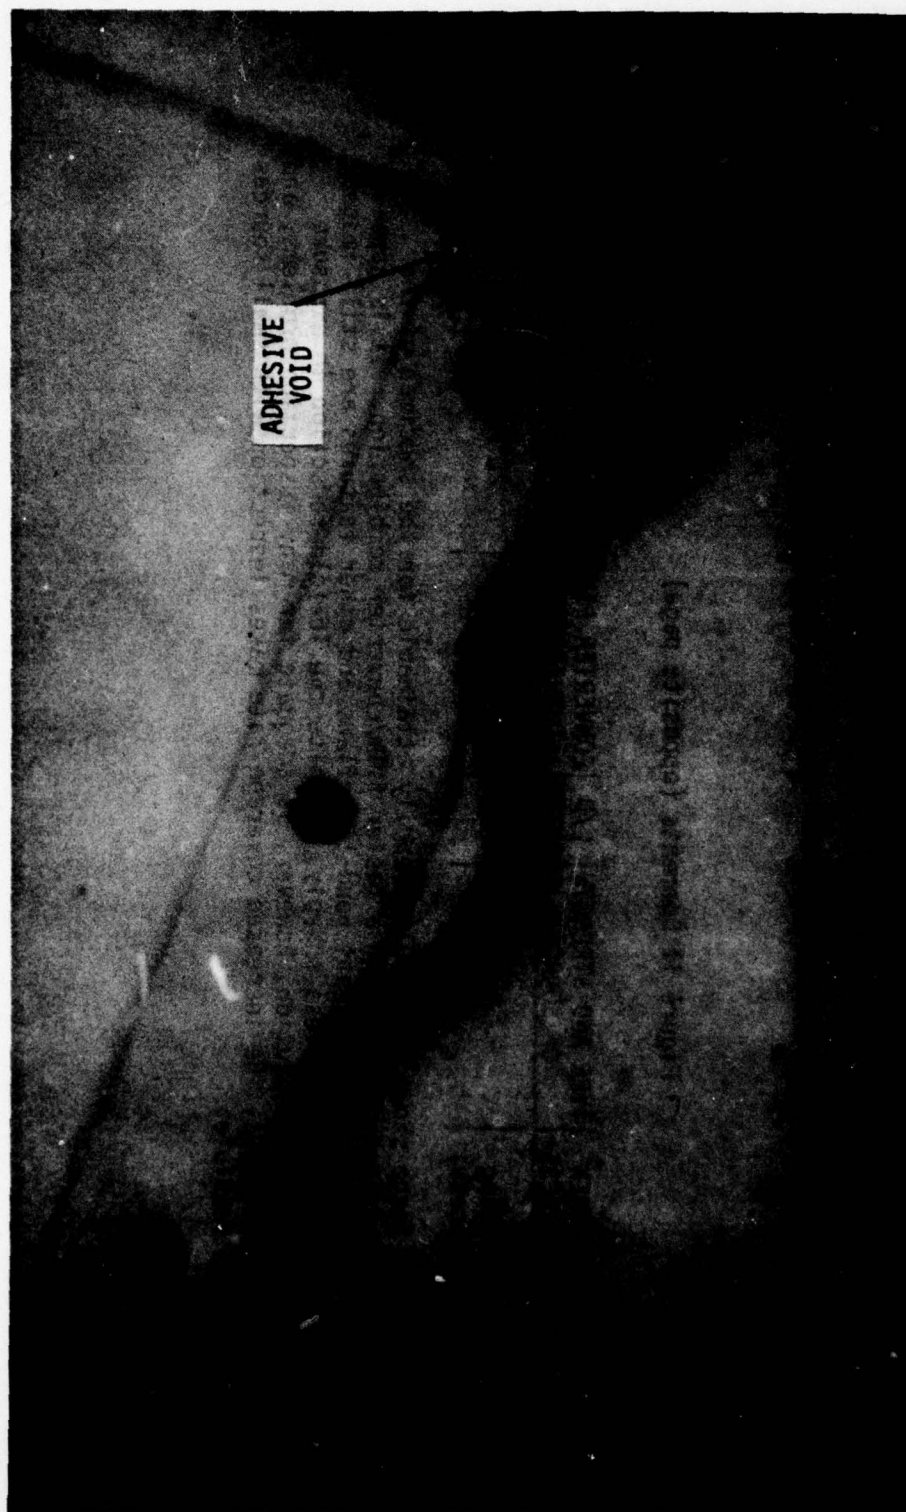
Figure 10 - Neutron Radiograph of Laminated Skin-to-Spar Joint in Aircraft Wing Section

This radiograph resulted from inspecting a complex joint in a thick laminated aircraft wing section. The area of interest is the laminated skin-to-spar bond line, which is critical to the structural integrity of the wing. A void in this bond line is imaged (arrow).

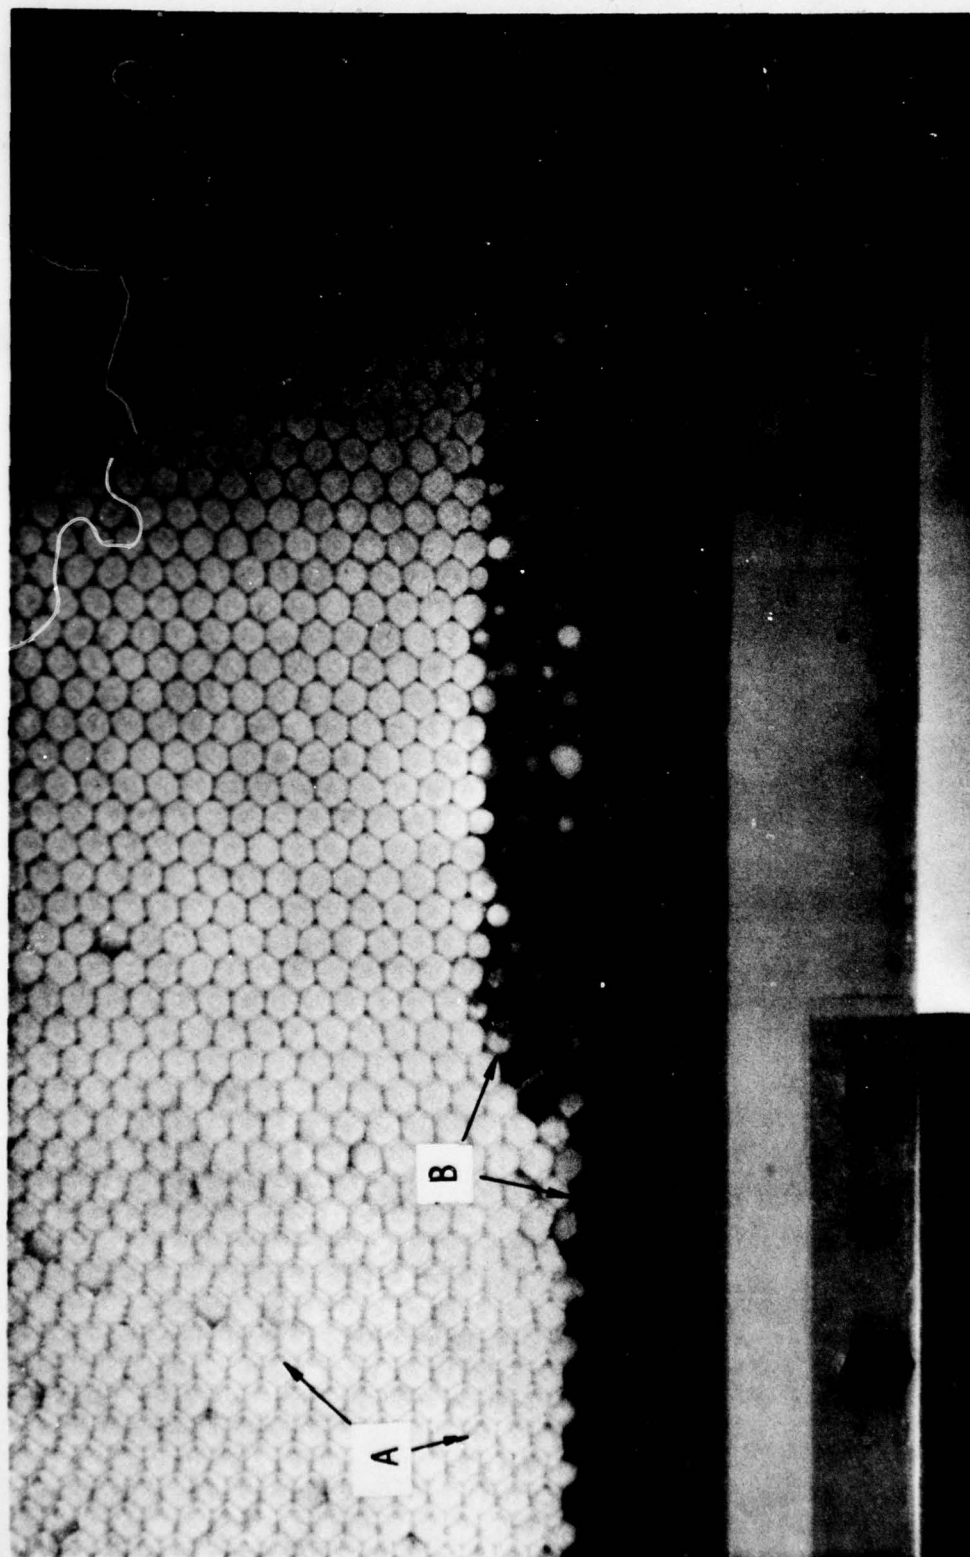
Figure 14 - Neutron Radiograph of Composite Skin/Aluminum Honeycomb Aircraft Wing Spoiler

This N-ray image of a graphite epoxy/aluminum honeycomb aircraft wing spoiler provides good indication of the distribution of adhesive at the core-to-frame interface (B), as well as the filleting of the adhesive at the skin-to-core interface (A).

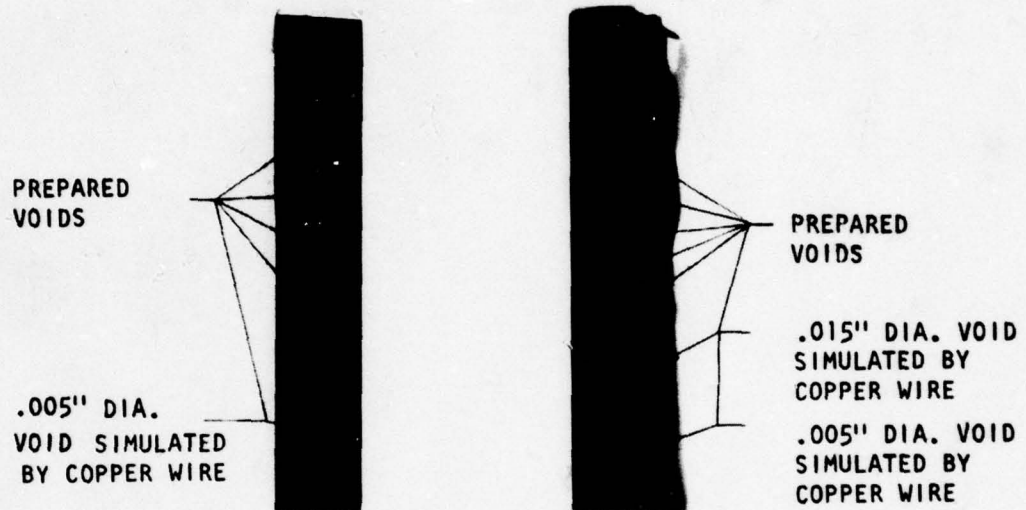
Figure 15 - Neutron Radiograph of Bonded Composite (Graphite Epoxy) Specimens

Voids in thin bond lines joining composite members can be radiographically imaged by use of a neutron opaque additive in the adhesive. This radiograph is illustrative of the contrast and resolution available when this technique is used. Void sizes, which are approximately full-scale, are as indicated on the print for simulated voids built into the specimen. The specimen at the left contained no metallic inserts while the one to the right contained a .065-inch titanium shim. These specimens were prepared from 0.10-inch graphite/epoxy panels joined by .005-inch bond lines.

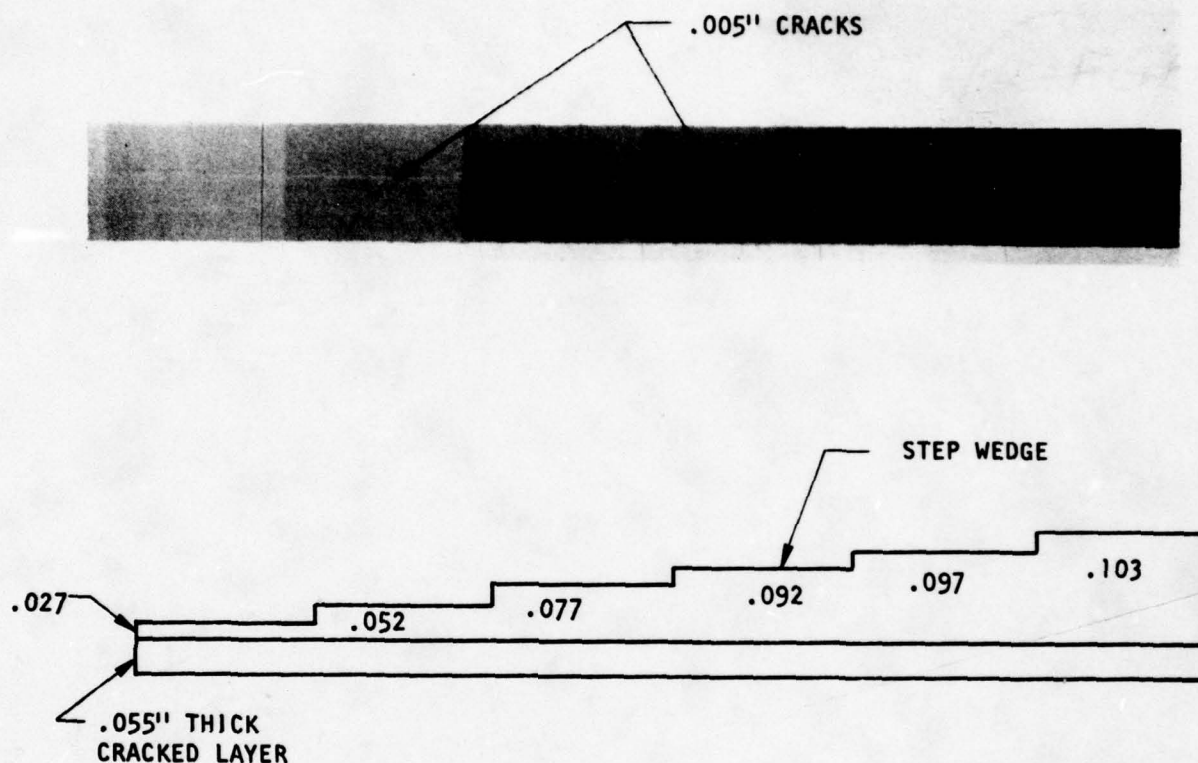
Figure 16 - Neutron Radiograph of Graphite Epoxy Specimen Containing Cracks in Sublayer

This neutron radiograph images .005-inch cracks in a .055-inch thick graphite epoxy sheet masked by a graphite epoxy step wedge having thicknesses ranging from .027 to .103 inch. This specimen simulated hidden internal crack damage.

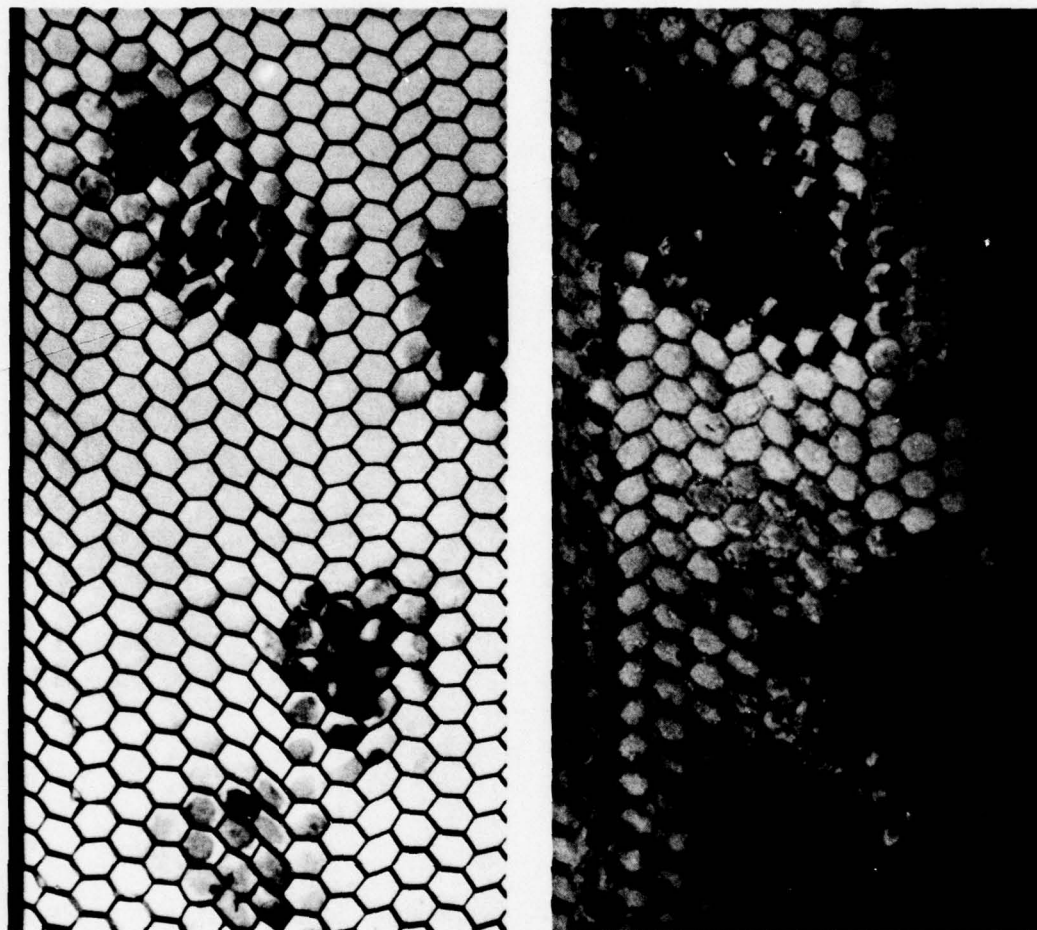
Figure 17 - Neutron Radiograph of Corrosion-Damaged Aileron Section

Corrosion damage in aluminum honeycomb at the skin interface is often detectable as a total absence of adhesive filleting, as shown in this radiograph of an aileron section on which extensive repairs had been made. When significant quantities of corrosion products are present, they are shadow imaged directly by neutron attenuation.

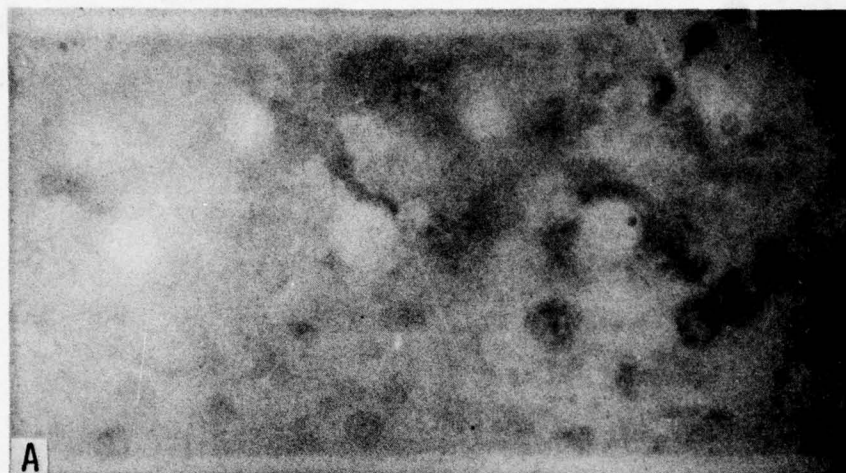
Figure 18 - Neutron Radiograph of Corroded F-8 Fuselage Panel

Shown here is a comparison of neutron radiographs of a small section of a highly corroded F-8 aircraft fuselage panel: (A) in "as-was" condition, (B) after removal of all surface corrosion from a portion of the specimen. The portion to the right of the arrow in (B) corresponds to that portion which is free of surface corrosion and images the exfoliation (dark areas) surrounding the rivet holes and spot-welds.

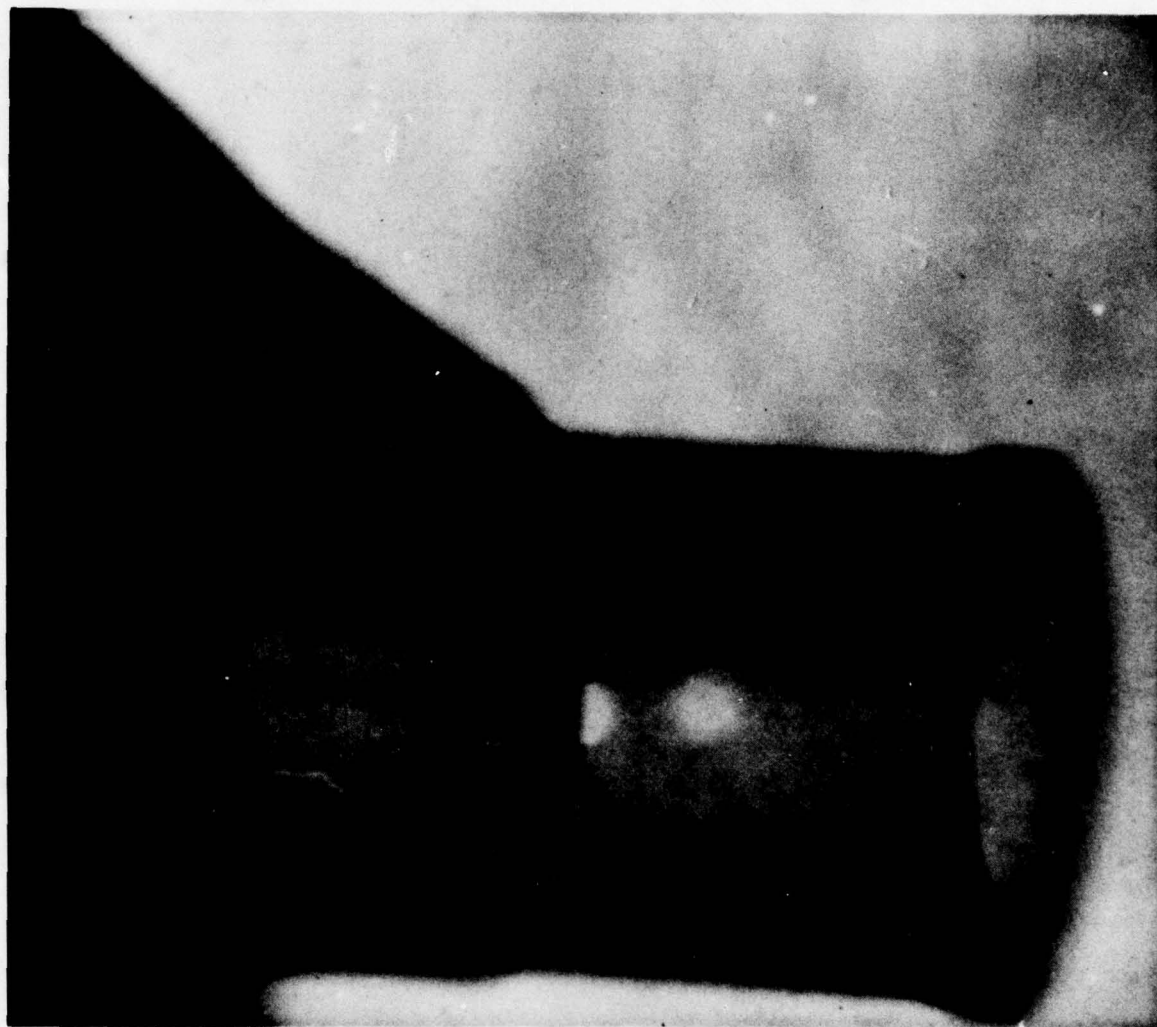
Figure 19 - Neutron Radiograph of A-7 Nose-Gear Housing

This radiograph is the result of N-ray inspection of the nose landing gear housing from an A-7 aircraft. Of primary concern was the inspection for corrosion on the inner wall of the aluminum housing which is hidden by the bronze bushings. The result shown here images corrosion products on that inner surface which houses the bushing.

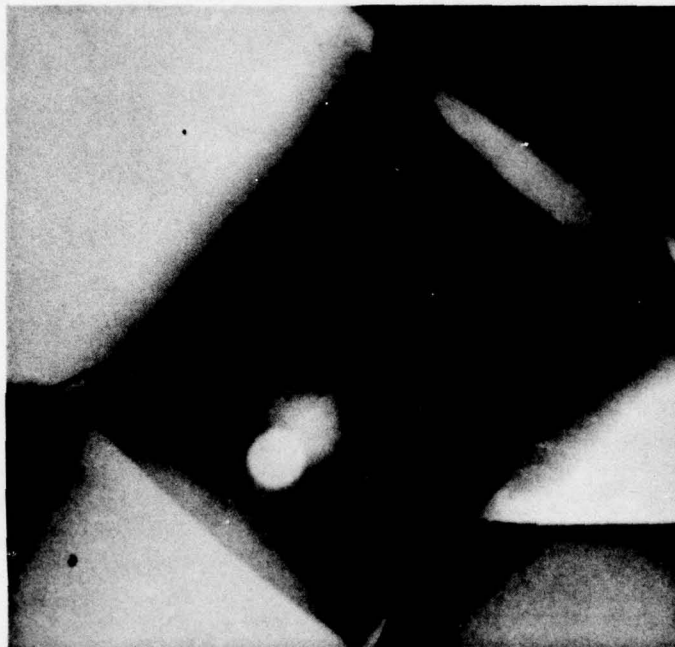
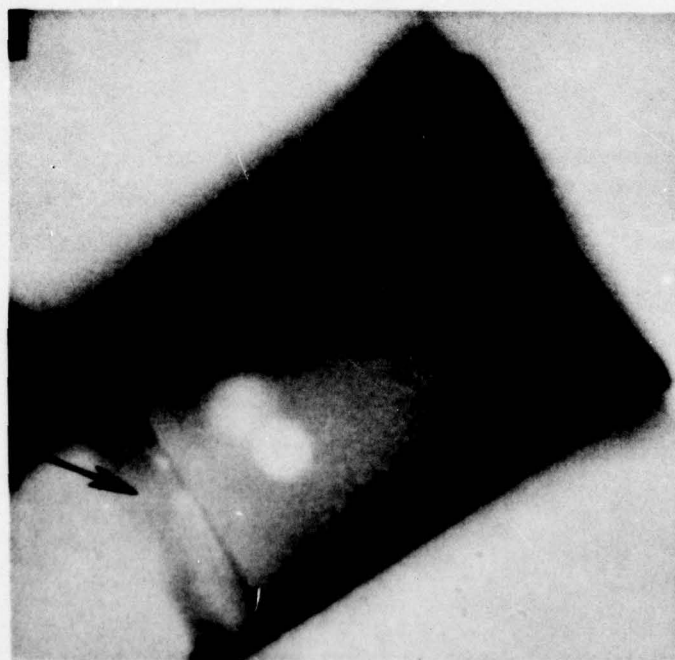
Figure 20 - Neutron Radiograph of Trunnion Bushing Area in A-7 Nose-Gear Housing

This radiograph resulted from inspection of another A-7 nose-gear housing before removal of the trunnion bushing. The dark spots are interpreted as clusters of sealant material or cadmium plating distributed in this manner during insertion of the bushing into the assembly.

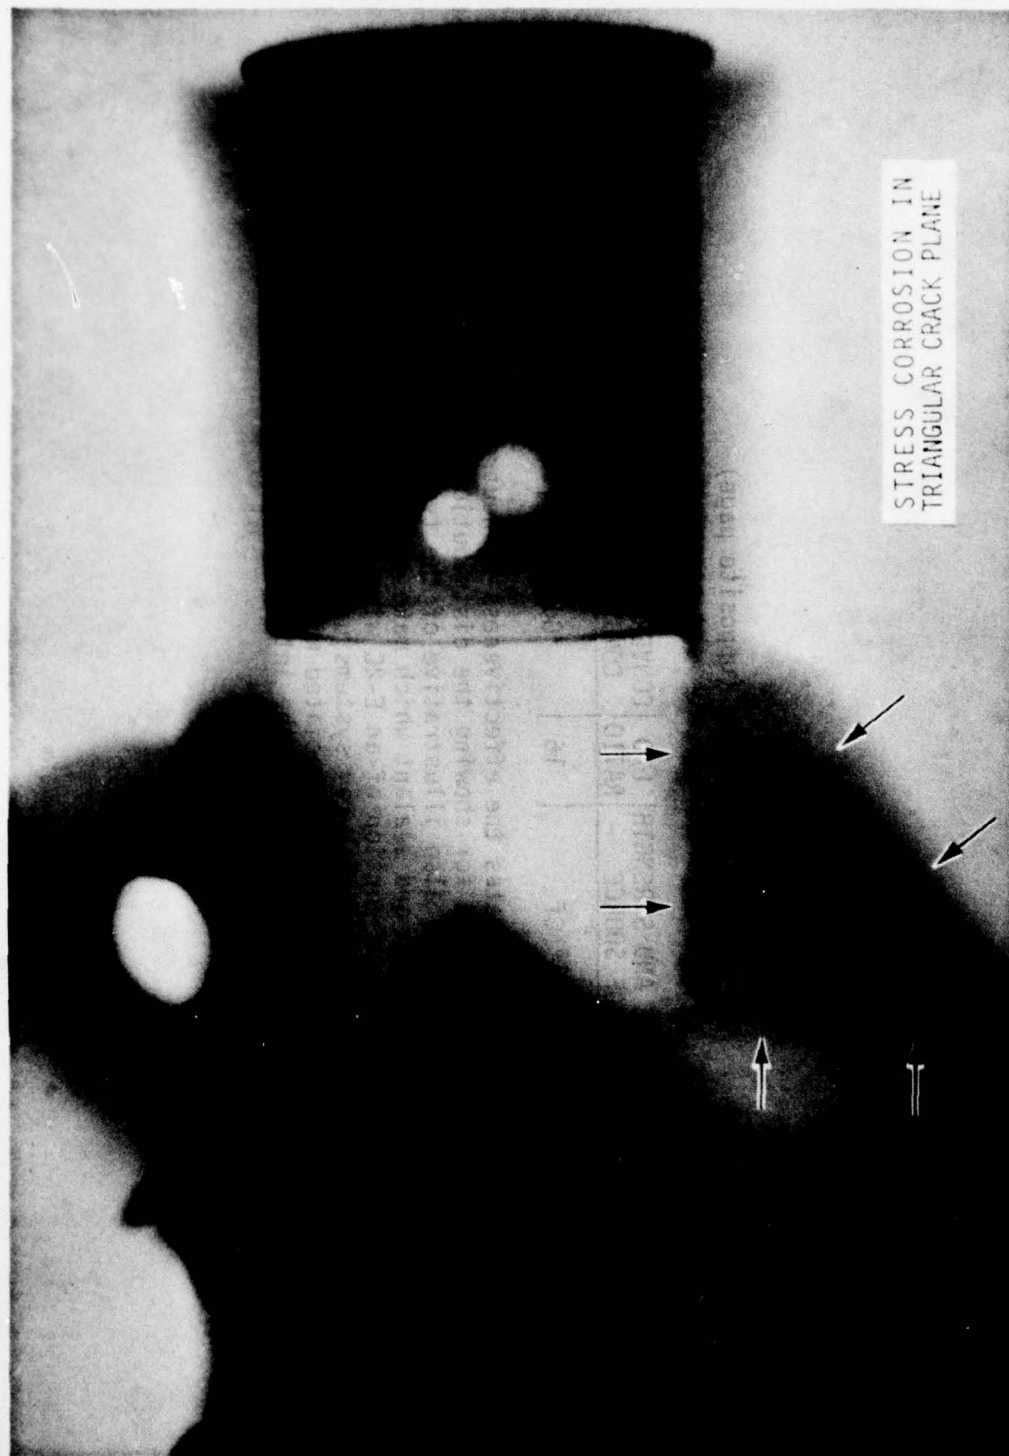
Figure 22 - Neutron Radiograph of Stress Corrosion Crack in A-7
Nose-gear Housing

This neutron radiograph of an A-7 landing gear housing shows clearly the extent, shape, and nature of a stress corrosion crack, which was barely detectable by visual inspection.

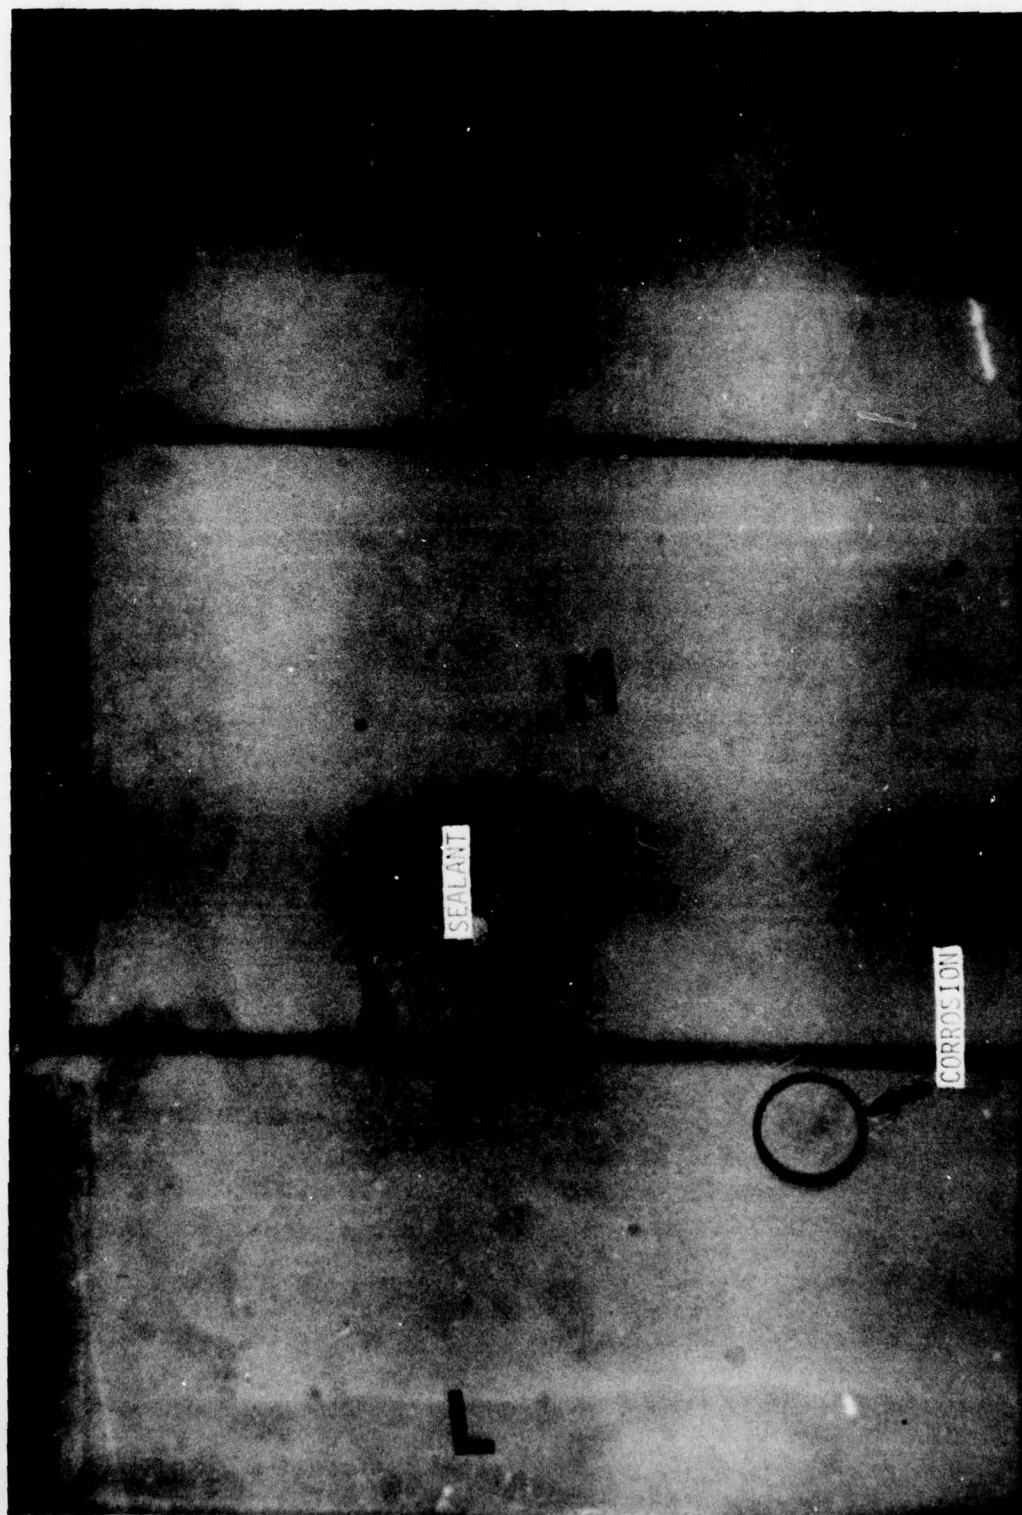
Figure 23 - Neutron Radiograph of E-2C Wing-Tank Structure

This radiograph illustrates the effectiveness of neutron radiography for imaging patches of corrosion and for showing the distribution of sealants within an aircraft structure. It is also illustrative of the typical differences in appearance between corrosion and sealant which make discrimination possible in most cases. This is from a portion of an E-2C wing tank. It should be noted that the short depth of focus of N-ray systems usually utilized for portable radiography highlights the features associated with the lower skin (in this case) and tends to ignore the other skin and the intervening structure.

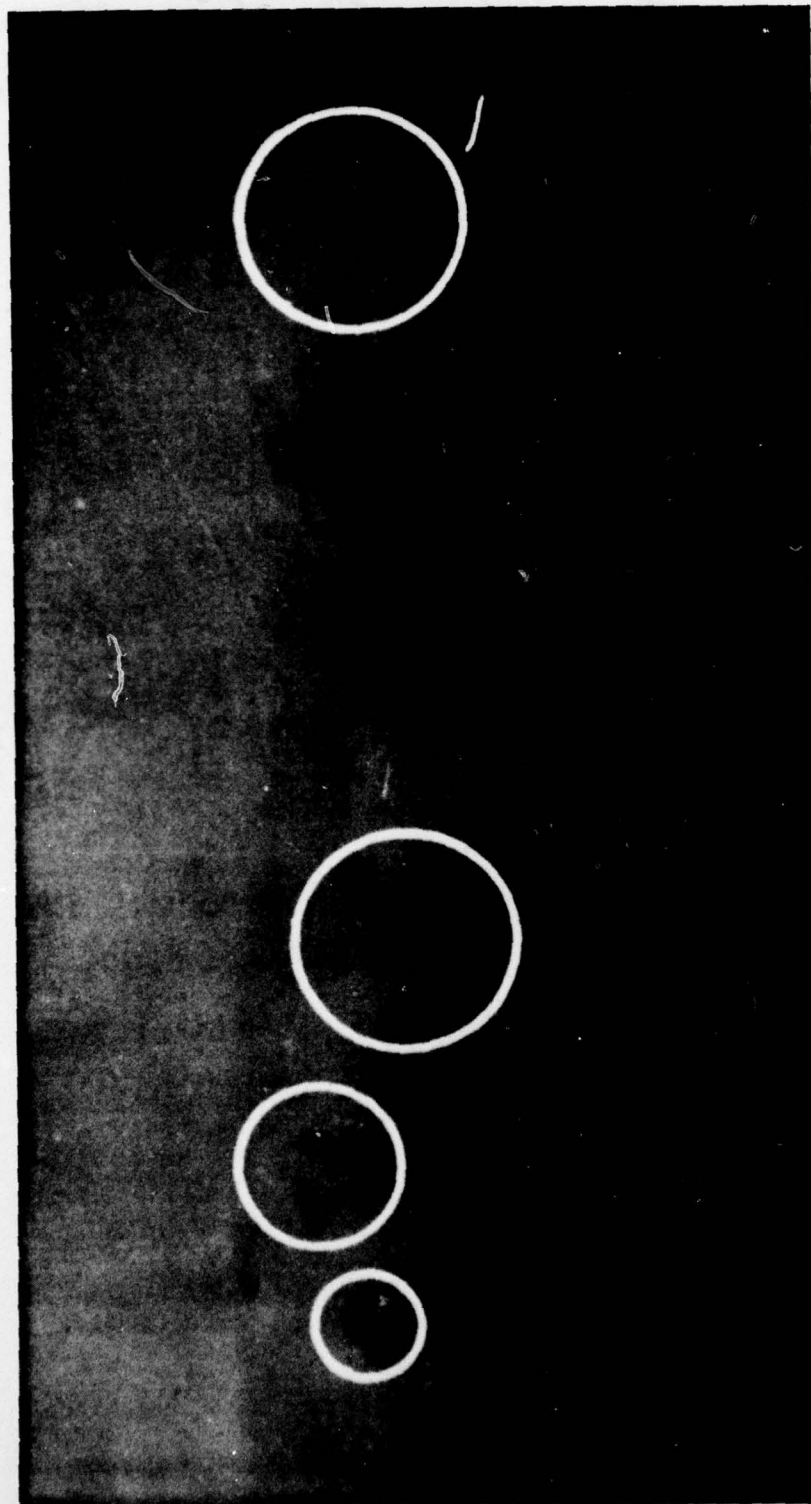
Figure 24 - Neutron Radiograph of E-2C Aircraft Wing Fuel Tank Structure

This radiograph is an example of neutron imaging of corrosion in the presence of sealant materials, where the corrosion is imaged through the sealant.

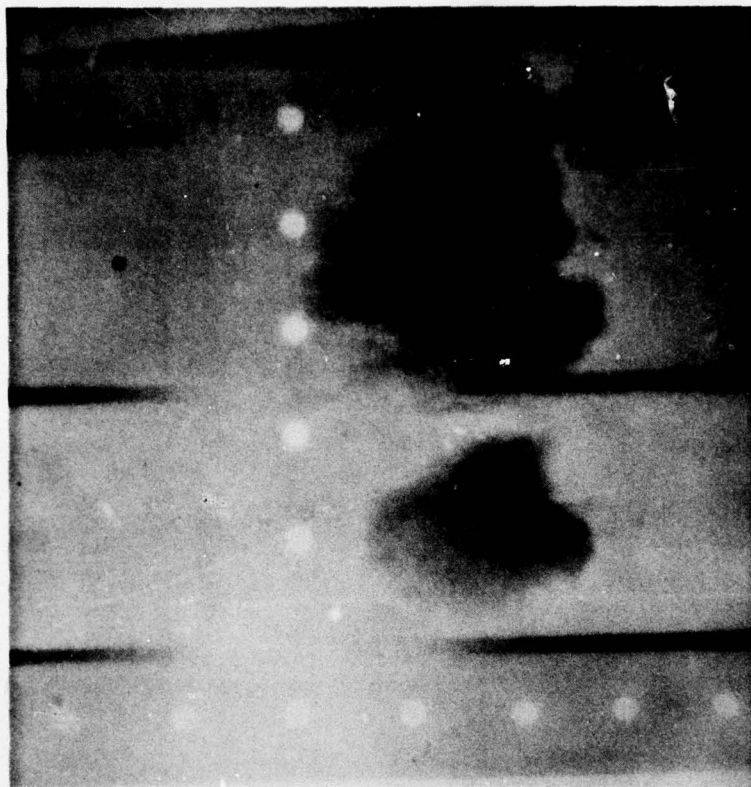
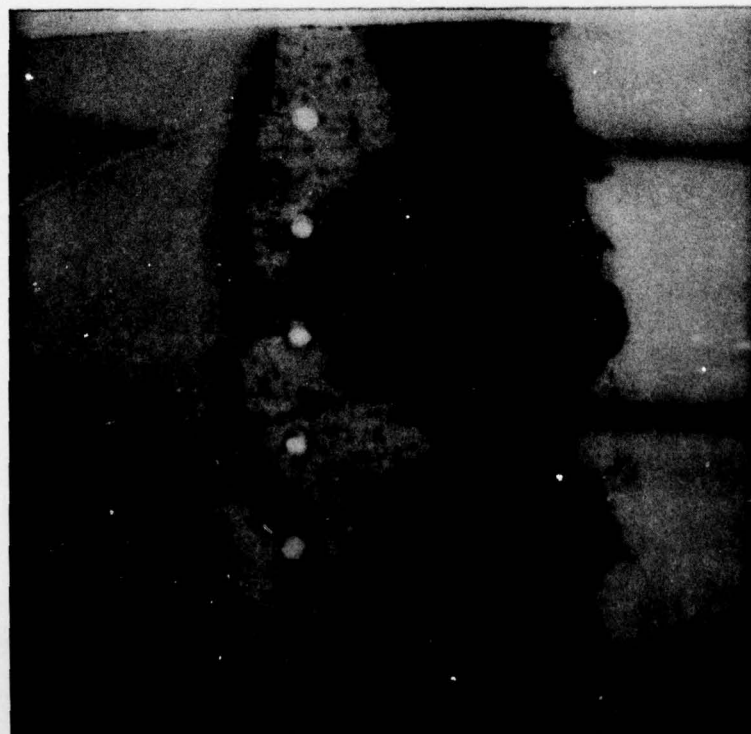
Figure 25 - Neutron Radiograph of C-130 Wing Structure

The radiograph on the right was obtained in the usual manner, and the one on the left with the use of a penetrant. The intergranular corrosion is seen to extend beyond the rivet holes, clearly explaining the cause of a fuel leak previously found in the structure.

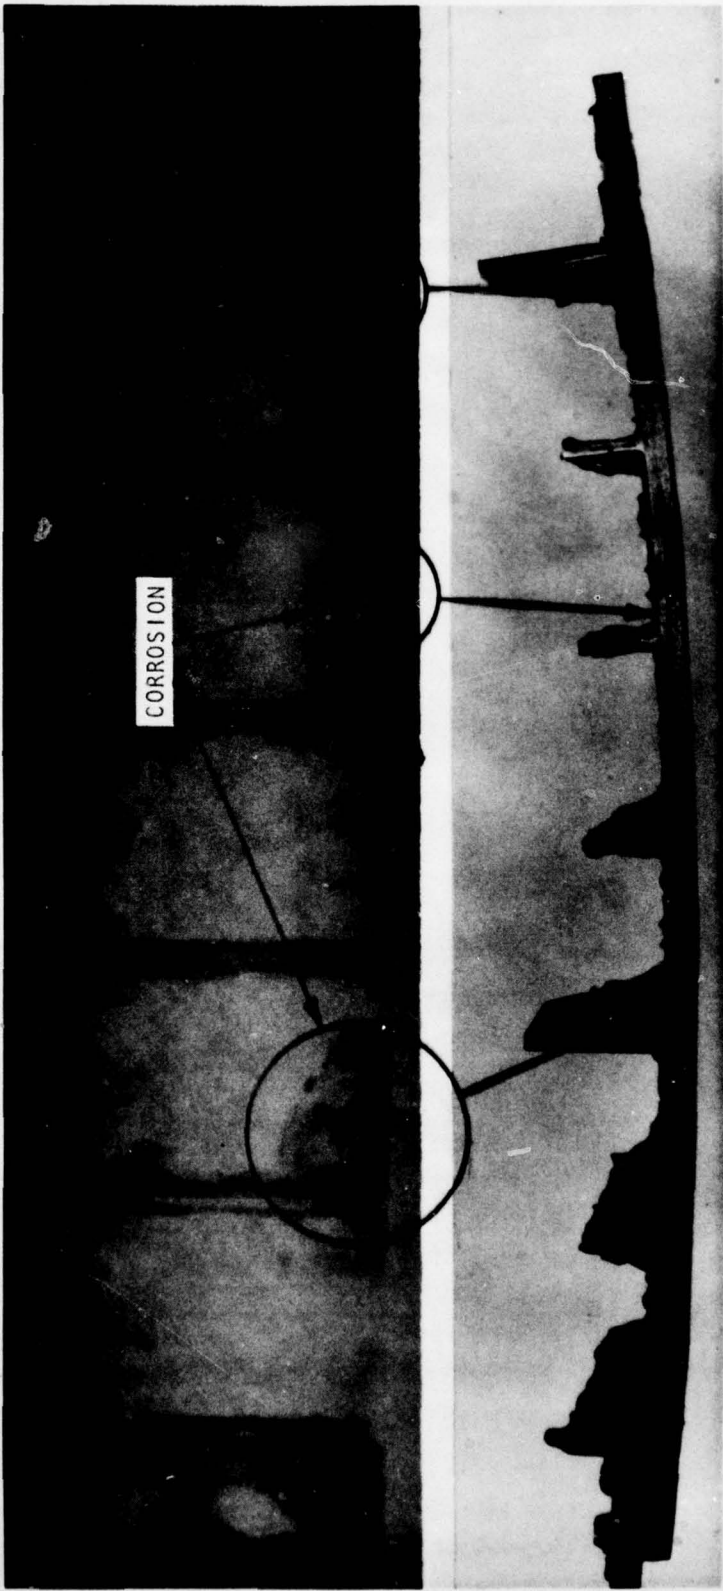
Figure 26 - Neutron Radiograph of Lower Skin of C-130 Aircraft Wing

Intergranular corrosion in the lower skin of a C-130 aircraft wing is imaged. Visual confirmation of this result was achieved upon sectioning of the skin, as seen in the edge photograph on the top.

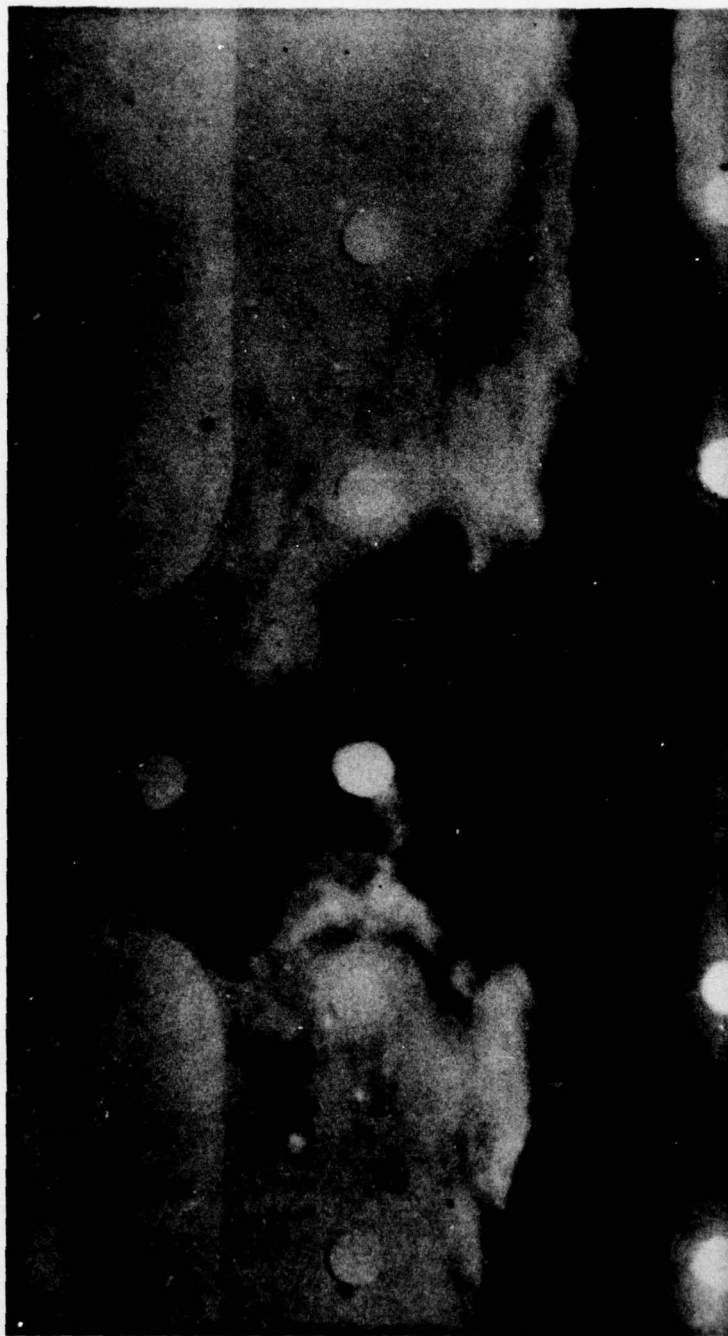
Figure 27 - Neutron Radiograph of F-4 Torque Box Panel

This neutron radiograph (enlarged) of a section of an F-4 torque box panel illustrates the high contrast attainable in some instances in detecting severe corrosion attack (dark area between the two rows of fastener holes and around one of the upper holes).

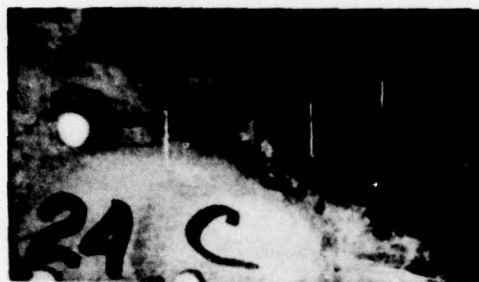
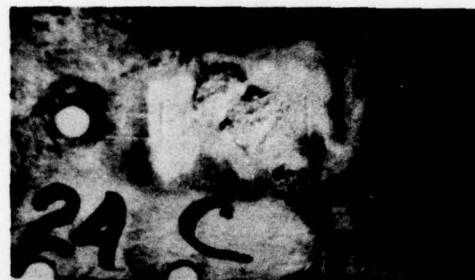
Figure 28 - Neutron Radiograph of A-5 Aircraft Skin

A portion of A-5 aircraft skin exhibits in this neutron radiograph corrosion pits surrounded by the familiar "ragged" rings of corrosion products which are typical of corrosion attack on aluminum skins. Photographs taken before and after removal of corrosion products reveal close resemblance of radiographic image to the damage pattern in the skin (bottom view).
